Biosafety Tips

This column describes how the Departments of Environmental Health and Safety (EH&S) and Maintenance joined forces to deal with moldy cold rooms in a new research building.

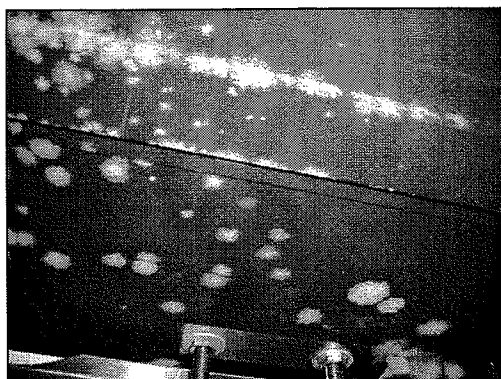
Figure 1

Clearly, the Smith Building cold rooms required dehumidification. The HVAC staff took a series of readings to independently confirm the problem, and worked with the cold room vendor to adjust the humidity with the existing systems. Meanwhile, some cold rooms had begun to smell moldy. Visual inspection revealed that mold had colonized the undercounter insulation of the stainless steel benches (Figure 1). One cold room was thoroughly disinfected; however, the mold had grown back over a 6-month period. The moldy undercounter insulation convinced the HVAC staff that a dehumidification system was required, because the same insulation material had remained uncontaminated for many years in the Dana Building cold rooms. When the HVAC staff surveyed the extent of contamination in the Smith Building cold rooms, they also removed a ceiling tile (Figure 2). Al Croteau, HVAC, used these images were used to support a budget request for mold remediation in the Smith cold rooms, followed by installation of a dehumidification system capable

Mold on Under-counter Insulation

On Saturday, mold remediation contractors came in and set up a contained, negative-pressure workspace with HEPA filtration. Cold room ceiling tiles were removed and packaged for disposal. Heat was applied to remove the soundproofing insulation under the stainless steel sink, counter, and shelves, and 10% bleach was used to disinfect all surfaces. The plastic duct attached to the HEPA filter was routed above the ceiling tiles and finally vented into

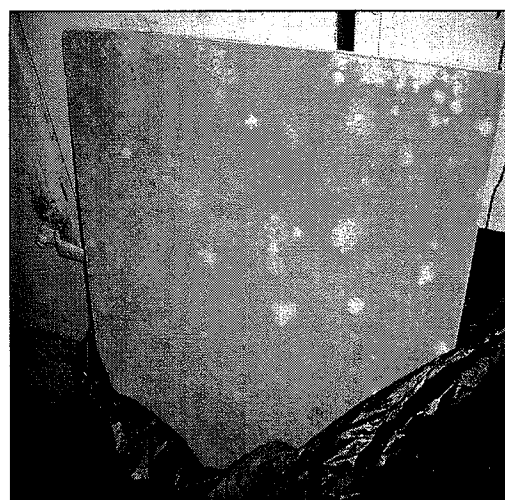
Figure 2

Cold Room Ceiling Tile

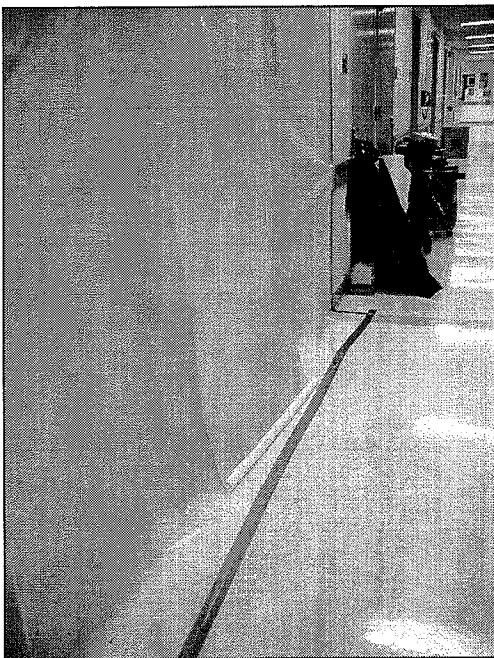
Figure 3

the stairwell corridors (Figures 3 to 5). Researchers were informed about the containment process, and so did not express concern when the mold remediation crew dressed in Tyvek and full-face respirators and disappeared behind the plastic barrier. No odor complaints were received during the mold remediation process, even though many researchers worked in the laboratories over the weekend.

Cold Room Remediation in Progress

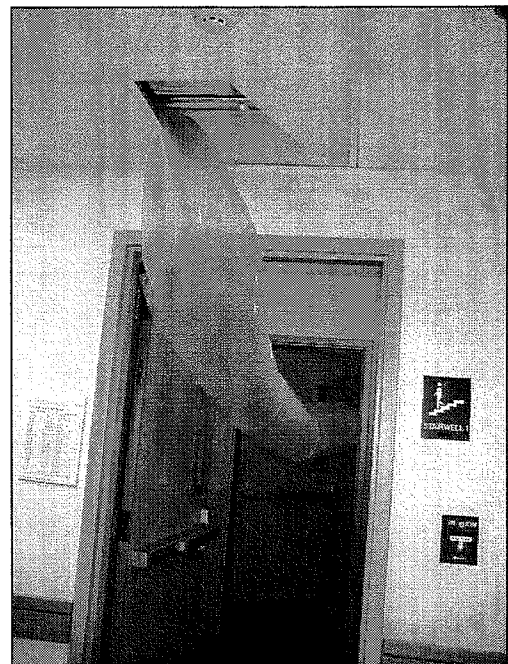
Figure 4

Exhaust into Stairwell
