Chlorine Dioxide Gas Decontamination of Large Animal Hospital Intensive and Neonatal Care Units

Henry S. Luftman¹, Michael A. Regits¹, Paul Lorcheim², Mark A. Czarneski², Thomas Boyle³, Helen Aceto⁴, Barbara Dallap⁴, Donald Munro⁵, and Kym Faylor⁶

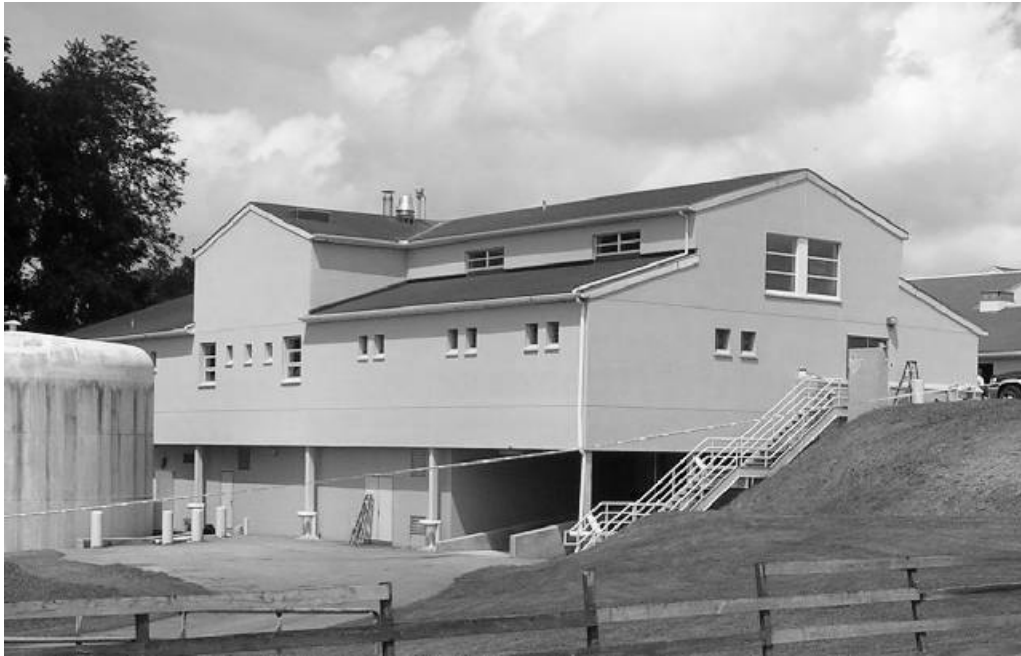
Figure 1

The ICU/NICU comprises a nearly isolated building, adjoined through one hallway to an equine orthopedic ward (Figure 1). The total volume of space considered for decontamination is approximately 4800 m³ (170,000 ft³). Its main floor is comprised of fifteen patient units with wooden sliding doors and appropriate facilities for providing food and waste disposal. This floor also has two nursing stations, a laboratory, a pharmacy, three restrooms, several offices and other smaller rooms. Two weighing stations were built into the floor and an overhead hoist system is present to facilitate the movement of patients and equipment. A second floor contains additional offices, a restroom, kitchenette, and a mechanical room housing the exhaust and supply blowers. Two basement rooms house additional mechanical and storage space, and two elevators and an internal stairway adjoin the floors. Although much of the space had been disinfected, office rooms remained furnished and contained files, as well as other personal effects. Interstitial spaces were visibly soiled. The interstitial space above the basement is open to the earth foundation under part of the building. The HVAC (heating, ventilation and air conditioning) system is 100% in/out. Most of the offices have window air conditioners.

George D. Widener Large Animal Hospital

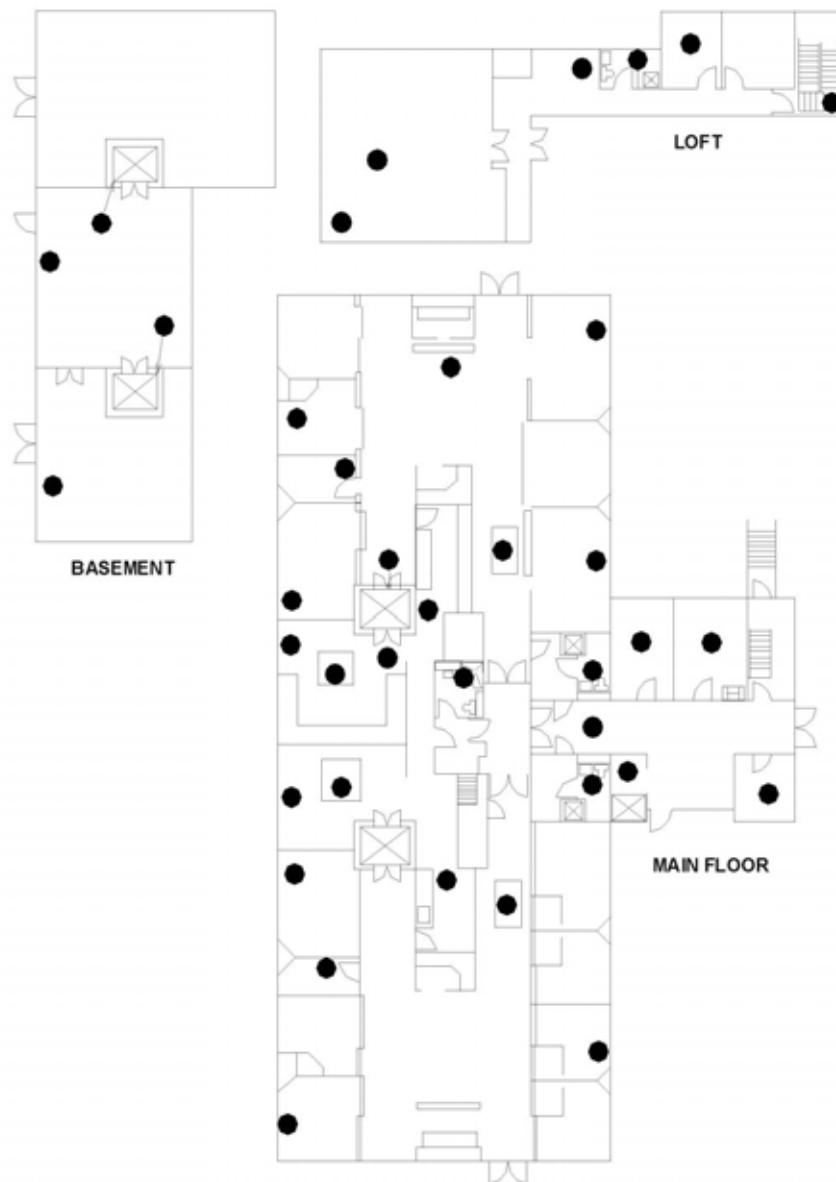
Figure 2

Biological indicators were aseptically placed a few hours before the decontamination throughout the building, including within ceiling interstitial spaces and the HVAC exhaust, to corroborate the efficacy of the decontamination (Figure 2). The indicators included (a) 40 unwrapped strips each with approximately 2 x 10⁶ spores of *G. stearothermophilus* (Spordex), which are considered to be the most difficult challenge for ClO₂ decontamination (Leighton et al., 2004); (b) 20 unwrapped spore strips of *B. atrophaeus* (Spordex), previously known as *Bacillus subtilis var. niger*; and (c) 40 strips inoculated with approximately 10⁹ colony forming units (CFU) of the bacterium *Salmonella* Newport. [The *S. Newport* test strips were prepared by the PADLS *Salmonella* Reference Center (SRC). They consisted of 1 x 1.5 inch absorbent paper with an impermeable plastic backing (Benchkote™), inoculated with 1 ml of a 10⁹ ml⁻¹ suspension of the bacteria. The strain of *Salmonella* had previously been isolated from an environmental sample submitted to the PADLS laborato-

Biological indicator placements. One *Geobacillus stearothermophilus* endospore and one *Salmonella* Newport test strip were placed at each location (•). One *Bacillus atrophaeus* endospore strip was placed at half of these locations (not indicated).
