Tradeline Publications: Uncovering Weaknesses of Biocontainment Facilities

Tony Della-Porta knows there is no such thing as a perfect biocontainment facility. He also knows the importance of improving standards, increasing safety, and enhancing staff training at BSL-3 and BSL-4 laboratories throughout the world. The bird flu virus and the SARS virus, both potentially fatal infectious agents handled by high-containment microbiology labs, present a compelling case about the need for more stringent standards.

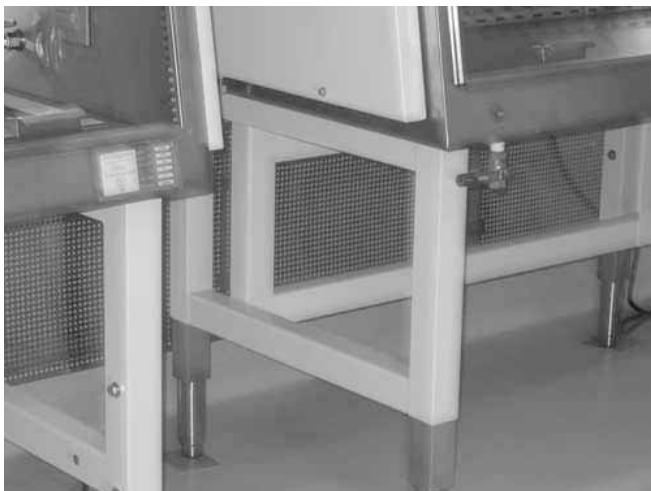
Figure 1

BSL-3

PRESSURE ZONE

Pressure differentials should ensure that a reversal of pressures cannot occur. The areas of highest risk, such as animal laboratories, should be at the lowest possible pressure to prevent pathogens from escaping into surrounding areas of lower risk. Pressure in the animal laboratory is at -120 pascals. One hundred pascals is equal to 0.4 inches of water. (Image courtesy of Tony Della-Porta.)

Pressure differentials are extremely important for maintaining containment of infectious diseases. Air pressure reversals were noted in high-security facilities where air was flowing in the wrong direction. There are also concerns about insufficient changes of air, especially since one particular facility had three changes per hour. The inability to control pressure differentials has caused walls to crack and ceilings to collapse. Pressure differentials must be adequate enough to ensure that a reversal of pressures cannot occur and that a sufficient differential is maintained even when the air lock is opened.

The areas of highest risk, such as animal laboratories, should be at the lowest possible pressure to prevent pathogens from escaping into surrounding areas of lower risk. Della-Porta is currently providing consulting services to a BSL-3 lab in Thailand that is handling the avian flu. Pressure in the animal laboratory is at -120 pascals, while the pressure in the labs is at -90 pascals, the decontamination chamber is at -75, the showers are at -30, and the surrounding service corridor is at 0 pascals. Della-Porta explains that 100 pascals is equal to 0.4 inches of water.

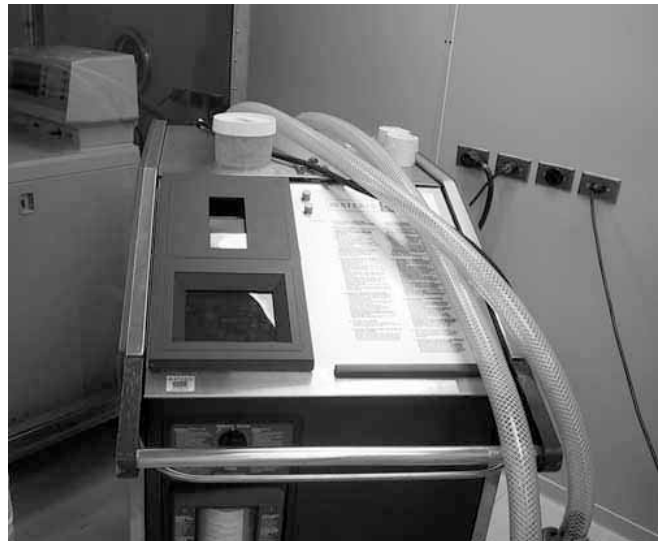
Figure 3

The SARS laboratory infection in Taiwan occurred because the person did not use a vaporized hydrogen peroxide generator like this one to clean up a spill. Instead, he used 70 percent alcohol and put his head in a BSL-3 biological safety cabinet without using a respirator. This room is not airtight because ordinary power points are mounted on the wall. (Photo courtesy of Tony Della-Porta.)

Power, communication, and gas services can be surface-mounted in moduline ducts. Ordinary power points and electrical fittings should not be mounted in walls because they will leak. Instead, special airtight plugs are necessary, unless a moduline fitting is used. Rubber gaskets for doors and pass boxes must be mounted correctly and be airtight when the door is sealed.

The 2003 SARS laboratory infection in Taiwan stemmed from a lack of management controls on the operation of the laboratory and training of staff. In this case, a principal investigator in a BSL-4 lab used 70 percent ethanol to decontaminate a spill in an isolator chamber. He opened the Class III biological safety cabinet without wearing a respirator and contracted the SARS virus.
