Tradeline Publications: USDA to Open New Lab and Large Animal Facilities in Iowa

The United States Department of Agriculture (USDA) operates a 480-acre campus in Ames, Iowa, that houses approximately 800 employees from two USDA agencies: the Agriculture Research Service (ARS) and the Animal and Plant Health Inspection Service (APHIS). Together, they comprise the National Centers for Animal Health.

The Ames campus is in the midst of a \$460-million modernization effort that will feature among other things a new consolidated laboratory facility and a biocontainment level 3-Ag large animal facility, and all of the associated central plant and infrastructure needed to support the facilities. The modernization effort is aimed at replacing older facilities built in the 1950s and the 1970s and creating a new state-of-the-art complex for diagnostics, research, and biologics evaluation for agricultural animal health.

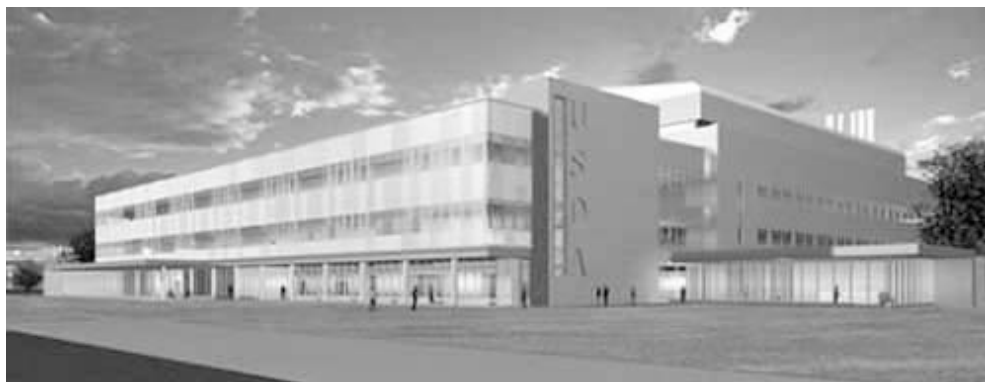
Figure 1

The USDA’s new 535,000-sf laboratory, targeted for completion in 2009, will include BSL-2 and 3 labs, a vivarium, offices, and training space. (Photo courtesy of U.S. Department of Agriculture.)

Approximately 700 scientific and administrative staff will be housed within the new four-storey, 535,000-sf consolidated lab. The facility will include three floors of laboratories constructed to the BSL-2 and -3 biosafety levels, a vivarium, scientific staff offices, and administration and support areas.

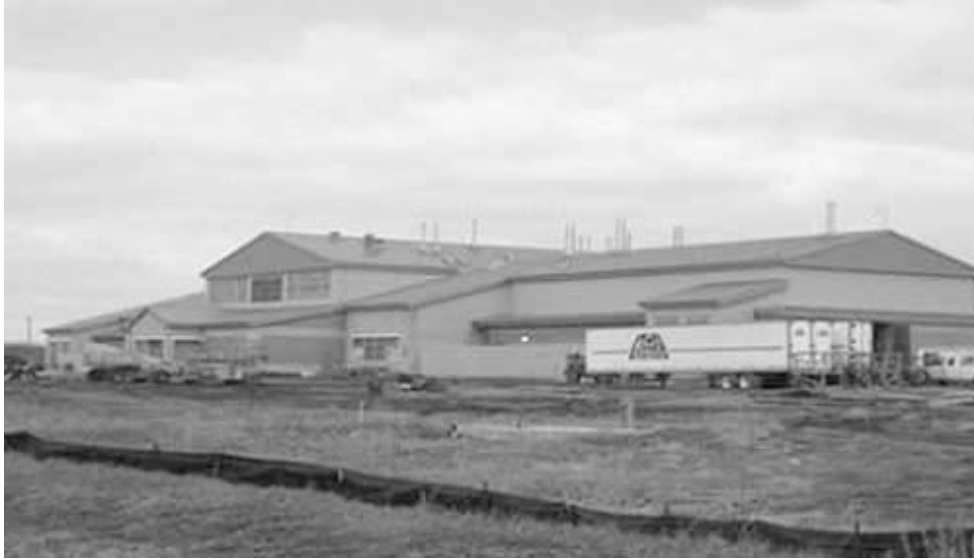
Figure 2

The new BSL-3Ag large animal facility is in the initial commissioning stages with occupancy projected for February of 2007. The high-containment facility will include 22 animal rooms for various species such as cattle, elk, deer, bison, sheep, and poultry. (Photo courtesy of U.S. Department of Agriculture.)

Many of the same scientific programs will use the new 153,650-sf large animal facility, which will feature 22 separate animal rooms to accommodate various animal species and multiple agents simultaneously. The animal facility is constructed to BSL-3Ag biosafety level standards, a standard unique to the agriculture industry, where the room itself serves as the primary containment measure.

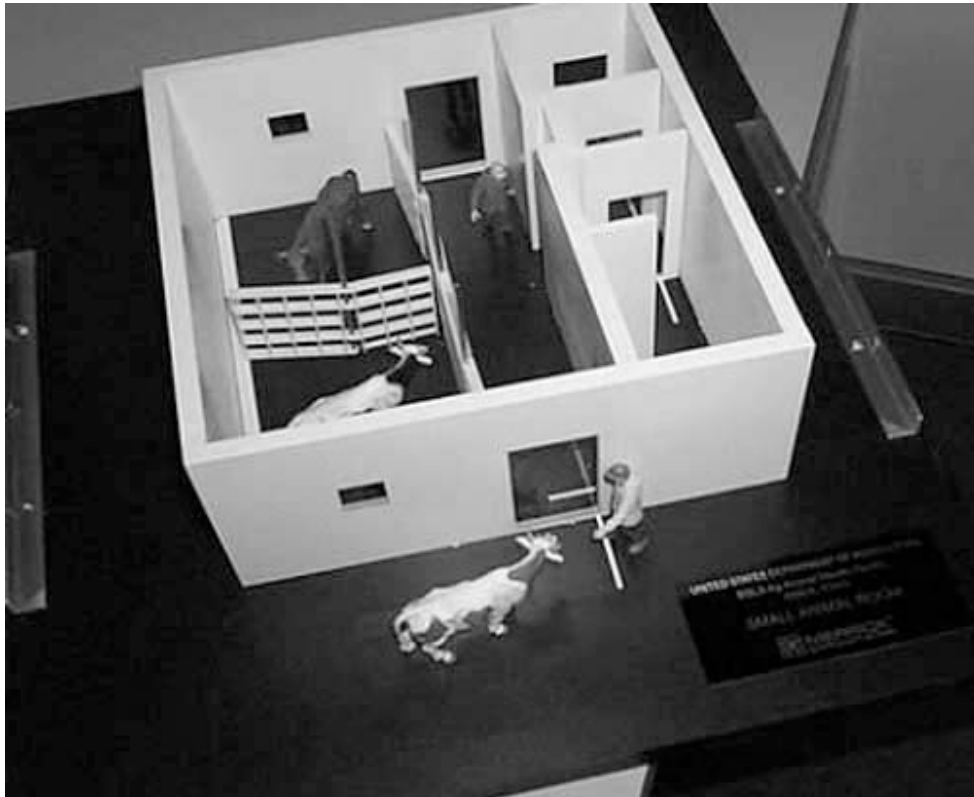
Figure 3

For its new BSL-3Ag large animal facility, the USDA used a variety of mock-ups including computer generated “tours,” scale models, vendor fairs, and functional/spatial mock-ups to determine the layout of pens and gating within the animal rooms and to test specific fixture elements such as gate hinges and pins. (Photo courtesy of U.S. Department of Agriculture.)

“We used full-scale plywood mock-ups of the animal rooms to ensure the penning and gating configurations allowed for the safe and efficient handling of the animals. The mock-ups also helped ensure equipment and devices were properly located since working with cast-in-place concrete walls presents a unique challenge when it comes to placing MEP embeds and duct penetrations,” says

A large-scale concrete mock-up was also used to test various concrete design mixes, and fit and finish elements, including the durability of epoxy coatings, the height and location of hose reels and sinks, the placements of penning and gating, and the room’s ability to withstand washdown and decontamination processes.
